Manhole Inspection Summary

Manhole # S33I__030MH

Insp Date: **11/12/08 2:30 PM**

Location Address: **w lombard st**

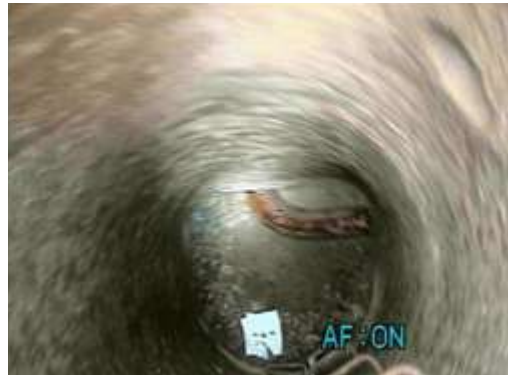
Top View

Condition: ☐ Sound ☐ Cracked ☐ Root Intrusion ☒ **Loose Brick** ☐ Deteriorated

Steps Count: **8** Missing: **0** ☒ **Corroded**

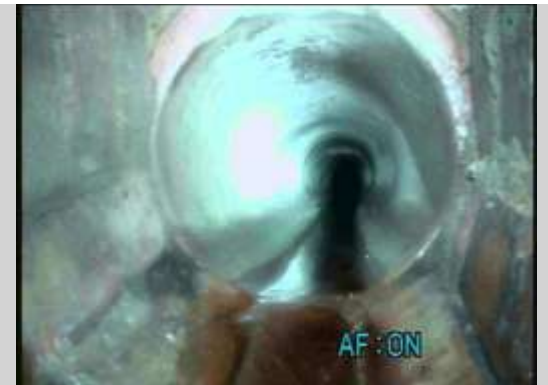
3 O'Clock Inflow

8 in. Circular Gravity Sewer
Pipe In @ 3 O'Clock

Pipe Material: **Clay** ☐ Pipe Lined

Infiltration: **None** Pipe Seal Cond: **Unknown**
